EVALUATION OF MIL-L-23699 LUBRICANT PERFORMANCE  
IN THE TF41-A-2 ENGINE

Naval Air Propulsion Test Center  
Trenton, New Jersey

NAPTC-PE-59

MAY 1975

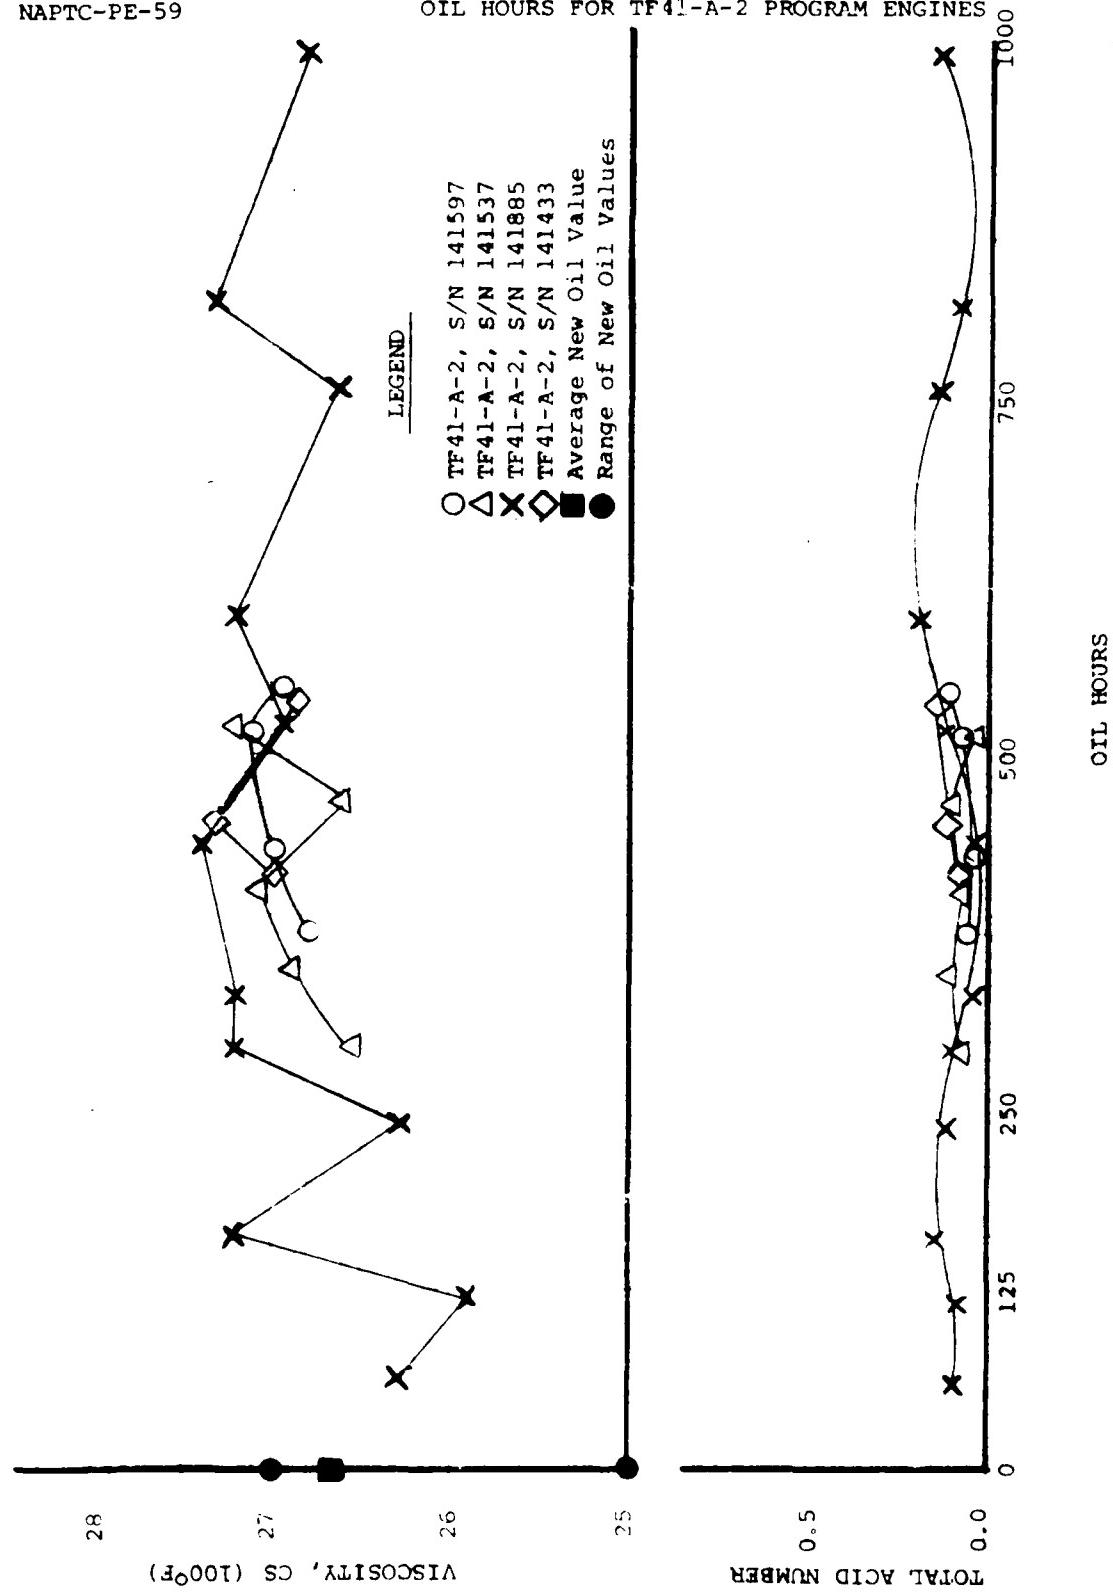
FIGURE 2: USED OIL VISCOSITIES AND TOTAL ACID NUMBERS  
VERSUS  
OIL HOURS FOR TF41-A-2 PROGRAM ENGINES

10. Figure 2 is a graphical representation of viscosity and TAN values obtained versus oil time in four of the program engines. The remaining engines experienced either oil losses or leaks which invalidated their usefulness to the program. As can be seen in Figure 2, there were no indications of oil degradation in any of the samples. Oil viscosity and TAN values did not vary significantly from new oil values indicating that no apparent physical or chemical changes in the lubricant occurred. The baseline tests were conducted on various batches of Qualification Number 0-9B MIL-L-23699B oil, for comparison to program samples. This was the oil primarily used by VA-174. Baseline values for viscosity (at 100°F) ranged from 25.0 to 27.0 centistokes (cs) with an average value of 26.7 cs. The maximum value, for viscosity at 100°F, reached on a program sample was 27.4 cs. TAN values of the program samples remained within new oil limits (i.e. less than 0.5).

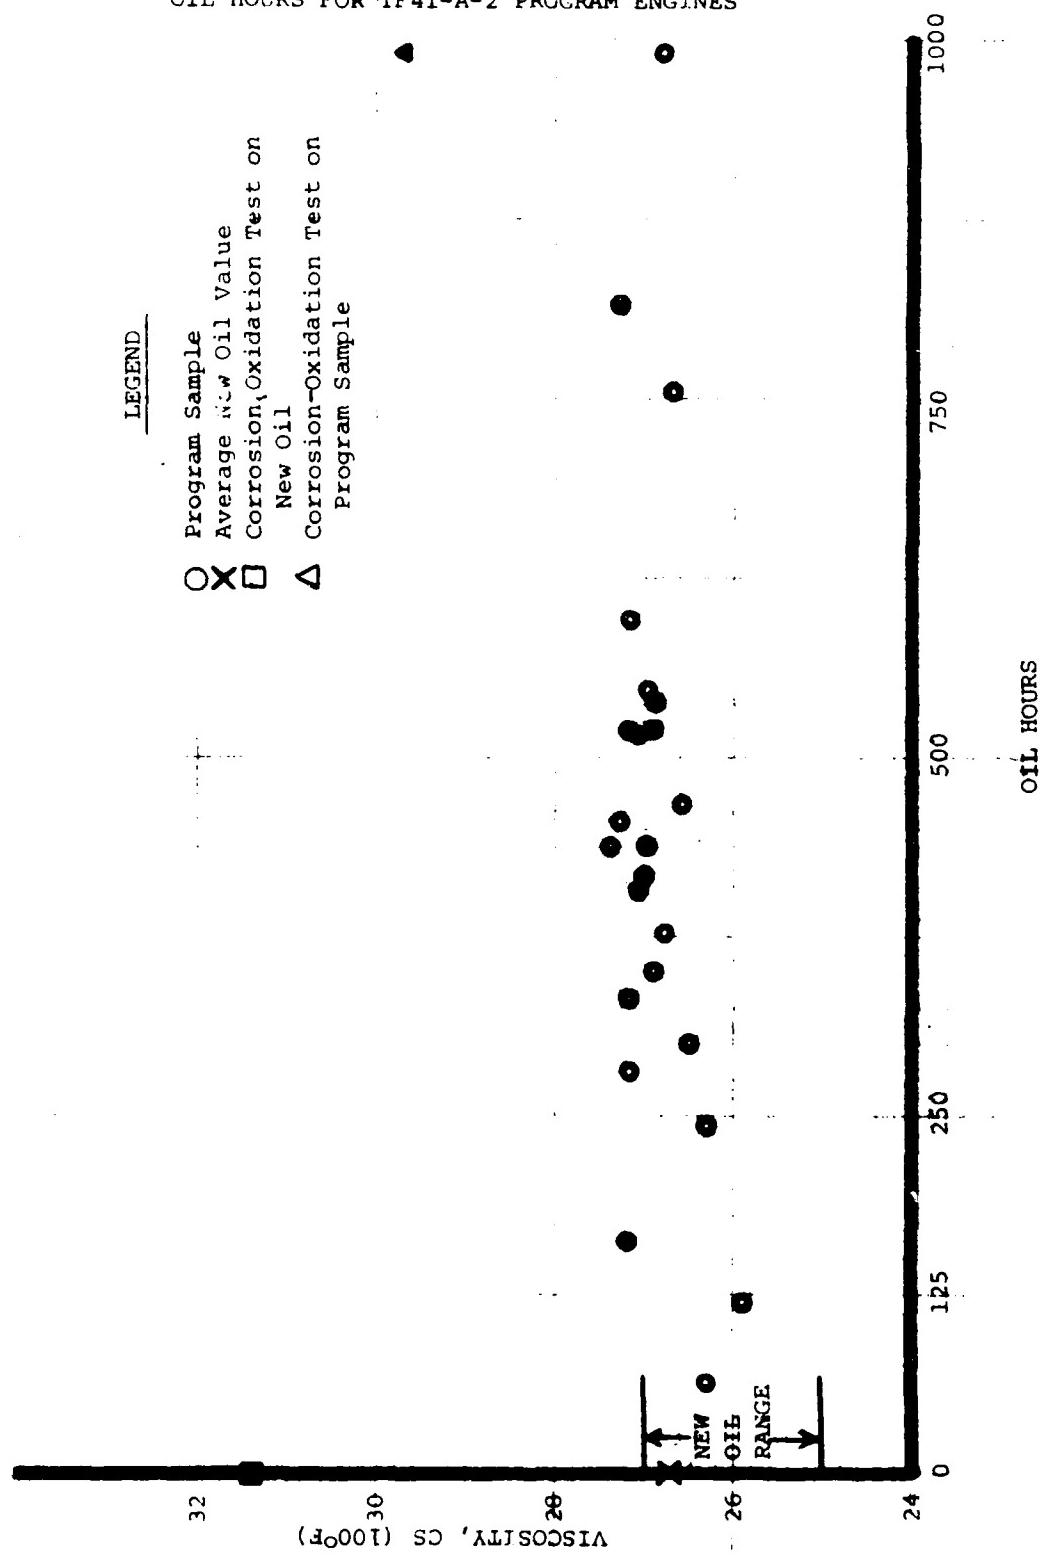
FIGURE 3: VISCOSITIES AND 400°F CORROSION-OXIDATION TEST DATA  
VERSUS  
OIL HOURS FOR TF41-A-2 PROGRAM ENGINES

13. A graphical representation of program samples viscosities and post Corrosion-Oxidation test viscosities is given in Figure 3. This figure shows graphically that: (a) viscosities of program samples up to 989 hours did not vary significantly from each other or from new oil values and (b) Corrosion-Oxidation test viscosities of a program sample (at 989 hours) did not vary significantly from new oil Corrosion-Oxidation test results. Therefore the oxidation stability and the corrosive tendencies of the program samples would be considered essentially those of new oil, and the used oil was capable of at least another 989 hours of engine operation which would permit approximately 1900 hours of engine operation without oil change.

1. Under normal TF41-A-2 operating conditions, MIL-L-23699B oil can be permitted to go up to 1600 hours between oil changes.
